**Monthly Water Balance Analysis
Upper Little River EA
Existing Conditions**

Monthly Water Balance Analysis
 Upper Little River EA
 Proposed Conditions

Sandwich South Employment Lands Upper Little River Existing Conditions

Document Title: Sandwich South Employment Lands –
Upper Little River Existing Conditions
Status: Draft Report
Version: 01
Date: December 2012
Project name: Sandwich South Employment Lands
Project number: 01-11-46
Client: Stantec
Reference: 01-11-46/01 - draft

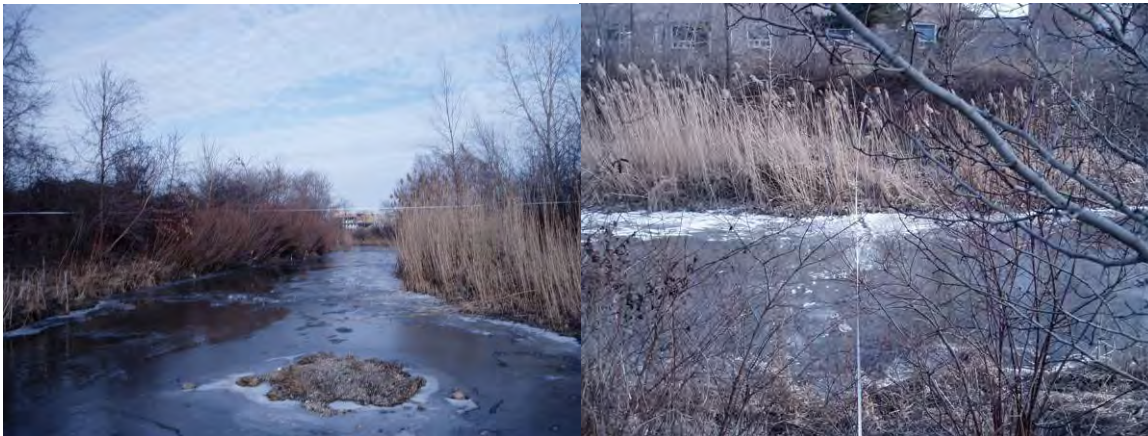
Figure 5.2: Example photographs for monitoring location at LR-3 (Dec 2004).

The average water depth for this monitoring cross section was measured at 0.15m with a wetted width of approximately 6.80m. Channel substrate consisted of a mixture of gravel and pebble sized particles. During the 2004 site visit a medial bar was observed upstream of the monitoring cross section that was also composed of a gravel and pebble mixture. One erosion pin was installed in the right bank of the monitoring cross section to measure changes in bank stability and mobility over the course of the monitoring program. A wetland was also noted along the right bank of the cross section. Below, are some monumented photographs that were taken at this monitoring location (**Figure 5.2**). Comparison of the cross sections from 2004 and 2007 show only a minor change in shape (**Figure 5.3**). The right bank shows slight aggradation.

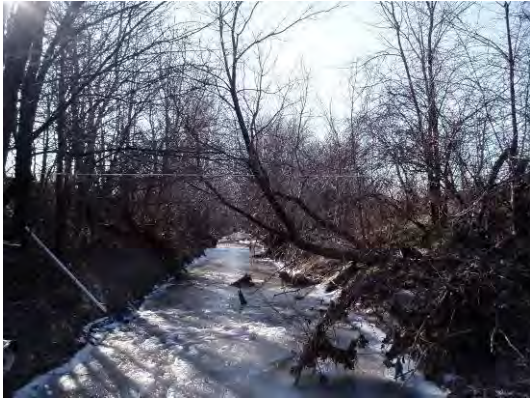
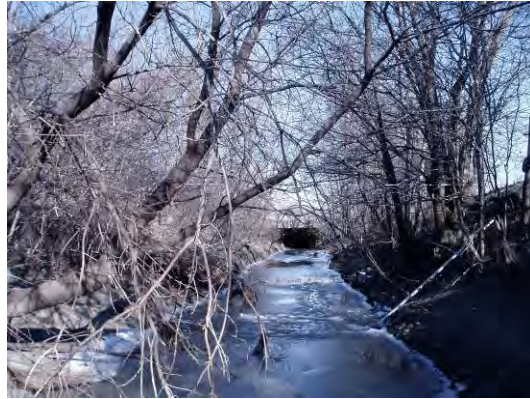
Reach LRD-4 is located in a residential parkland area with some commercial/industrial land use. This portion of Little River Drain appears to have been previously straightened as the channel has a wide 'U'-shape. The banks appeared to be eroding evidenced by exposed tree roots. Sparse vegetation was present on the banks during the site visit with little evidence of growth in the summer. The bank vegetation consisted of mature trees and shrubs growing out of a sand-silt soil. The soil appears to have been deposited during high flows. Channel substrate consisted of a pebble-sand-silt mixture with little-to-no channel vegetation present. Bankfull width was estimated to be 6.15 m with a depth of 0.67m, and a wetted width of 4.04m and depth of 0.20 m. There were no erosion pins installed at this monitoring cross section during the site visit. Below are the monumented photographs taken for this monitoring site (**Figure 5.4**). The channel bed has been elevated due to aggradation between the monitoring in December 2004 and May 2007 (**Figure 5.5**). Minor changes in bank shape support the contention that bank soil is being deposited during high flows.

Figure 5.4: Example photographs for monitoring location at LRD-4 (Dec 2004).

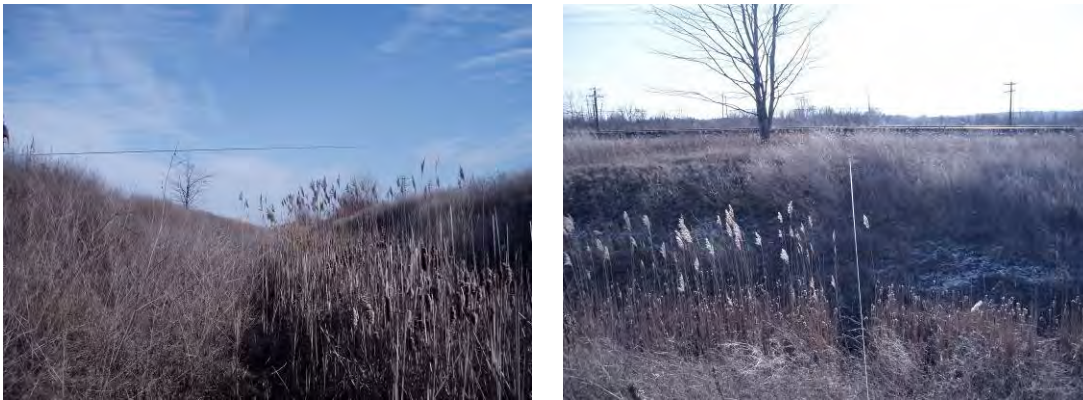
Reach LAD-1 is a tributary of Little River known as Lachance Drain. It appears to be a straight, dug drainage ditch flowing through mainly agricultural land with some commercial/industrial land uses in the downstream portion. The downstream portion of the reach is also located near the rail line servicing the northern portion of Windsor. The channel appeared to be highly entrenched with a distinctive 'v'-shape to the valley. There was no noticeable bank erosion and the channel appears to convey low flows only. The bankfull width calculated for this site was 8.5m with a bankfull depth of 0.78m. The channel was at low flow during the site visit. The wetted width was 2.56m with an average depth of 0.035m. Bed substrate consisted of a mixture of silt and fine sands with a lot of vegetation (cattails) growing throughout most of the reach. Below are the monumented photographs taken for this monitoring cross section (**Figure 5.6**). Field crews were unable to relocate the monitoring cross section in 2007; therefore comparative cross section overlays cannot be shown (

Figure 5.6: Example photographs for monitoring location at LAD-1 (Dec 2004).

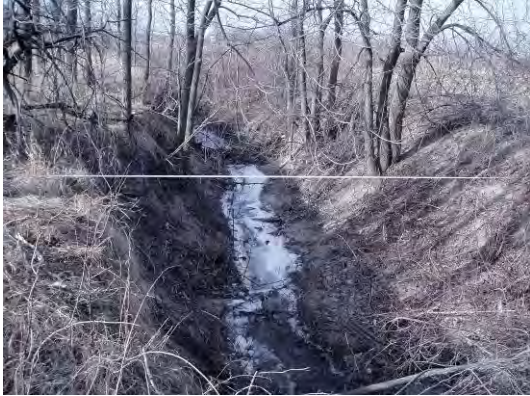
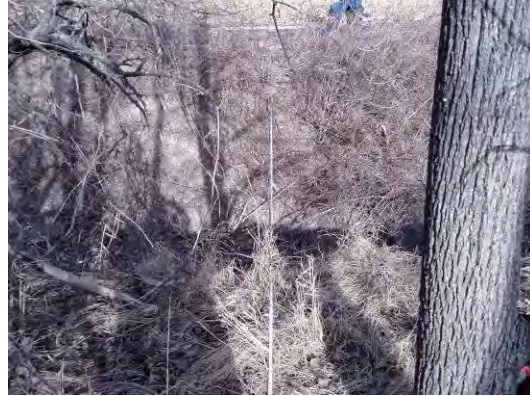
Figure 5.8: Example photographs for monitoring location at DD-1 (Dec 2004).

This reach flows as an agricultural drain into the eastern edge of Little River upstream of Lachance Drain. The surrounding land use is dominated by agricultural fields and scrub lands. Bank vegetation consisted of trees, shrubs (raspberry bushes), and tall and short herbaceous vegetation. During the site inspection, there was sufficient woody debris in the channel to create barriers to flow and backwater. Bank erosion that extended to the top of bank in some areas was also noted along a portion of the reach. There did not appear to be a lot of under-story vegetation present near the monitoring cross section and the trees located along the bank did not appear to be leaning, suggesting that the bank erosion is slow. Channel substrate consisted of sandy silt to sand mixture. Estimated bankfull width for this monumented site was 5.1m and the bankfull depth was 0.88m. The wetted width observed for this site was 1.21m with an average wetted depth of 0.07m. One erosion pin was installed at this cross section in the left bank approximately 5m downstream of the monitoring cross section. Monumented photographs for this reach can be found below (**Figure 5.8**). Field crews were unable to relocate the monitoring cross section in 2007; therefore comparative cross section overlays cannot be shown (**Figure 5.9**).

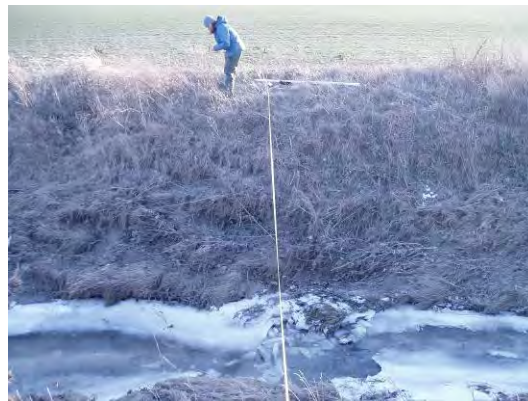
Baseline Road Drain (BRD-1) joins the Little River Drain near 6th Concession Road. The entire reach is surrounded by agricultural land and appears to flow as a drainage ditch along 6th Concession Road. Bank vegetation consisted of a mix of shrubs with tall and short herbaceous vegetation. Channel substrate consisted of a mixture of fine sand and silt. There did not appear to be woody debris in the channel during this site visit. Bankfull was estimated to be 4.6m width, with a depth of 0.59m, a wetted width of 1.42m and an average wetted depth of 0.19m. Two erosion pins were installed at this monitoring cross section. The first was installed in the left bank approximately 2.0m upstream of the monitoring cross section, and the other one was installed approximately 8.5 m downstream of the cross section. The photographs below illustrate the site characteristics (**Figure 5.10**). The site was re-measured in May 2007 (**Figure 5.11**). The changes in channel shape suggest that the ditch was cleaned out with the help of a backhoe. This is a standard practice in rural areas when municipal drains become overgrown with channel and bank vegetation.

Figure 5.10: Example photographs for monitoring location at LRD-4 (Dec 2004).

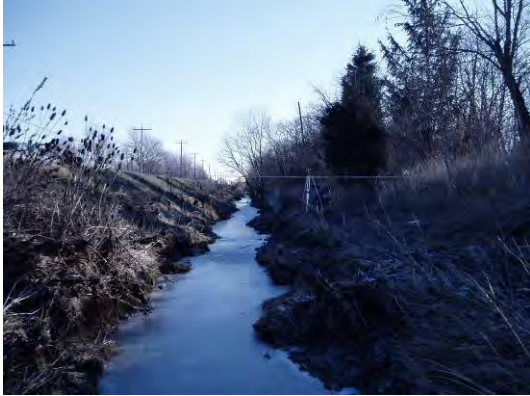
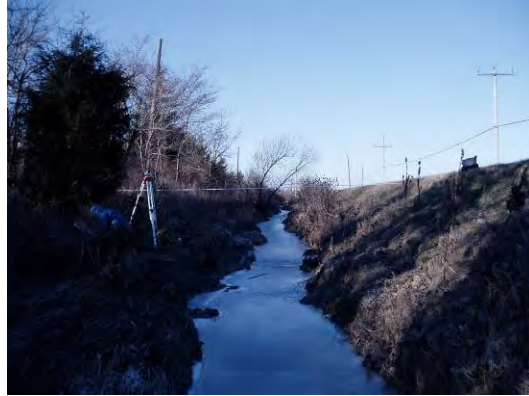
This reach is the terminal section of the 6th Concession Road drain before it becomes the Baseline Road Drain which ultimately flows into the Little River Drain. The surrounding land use for this portion of the 6th Concession drain consisted mainly of residential development and associated infrastructure, with some agricultural land use still visible. The left bank of the channel abuts 6th Concession Road. Bank vegetation consisted of a mixture of tall and short grasses and herbaceous vegetation with some trees and shrubs along the residential side of the channel. The left bank appeared to be slumping with some scars visible along the bank. Channel substrate consisted of a mixture of silt and fines. Observed bankfull width was 3.7m with a bankfull depth of 0.43m. The wetted width was not that deep during the site visit with a wetted width of 1.32m and an average wetted depth of 0.12m. Two erosion pins were installed at this monitoring cross section, one in the right bank and the other in the left bank, both immediately at the cross section. The monumented photographs taken for this reach are below (**Figure 5.12**). Cross-section measurement was repeated in May 2007 (**Figure 5.13**). Change in cross-sectional shape indicates slumping of the left bank and toe erosion of the right bank.

Figure 5.12: Example photographs for monitoring location at SC-1 (Dec 2004).

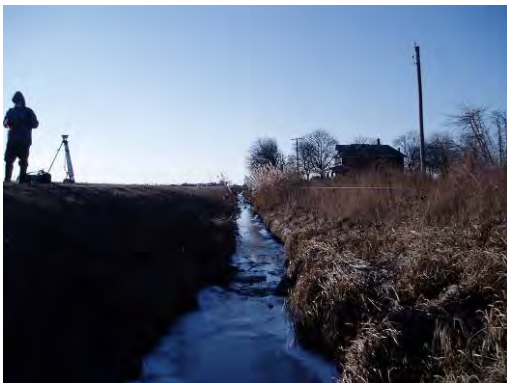
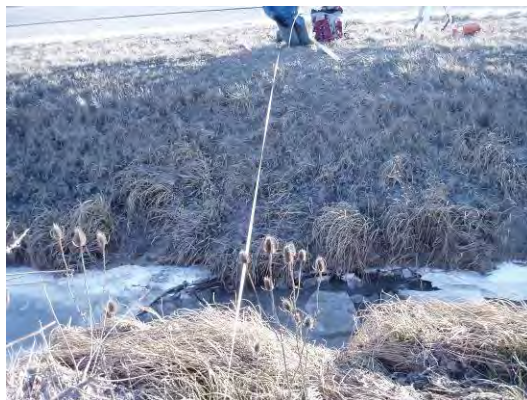
This reach flows along the 9th Concession Roadway as a roadside ditch, before joining with 6th Concession Drain (SC-1) and becoming the Little River Drain (LRD). Surrounding land use consists mainly of agricultural fields with some residential development and associated infrastructure. Bank vegetation consisted of a mixture of tall and short grasses and herbaceous vegetation. Channel substrate consisted of a pebble-sand mixture with some large boulders in the channel near the cross section. Bankfull width was estimated to be 4.3m with a bankfull depth of 0.57m. The wetted width from this cross section was observed to be 1.34m width with an average depth of 0.12m. There were no erosion pins installed at this monitoring cross section. The monumented photographs below highlight the findings for this reach (**Figure 5.14**). The cross section for Reach NC-1 was the only monitoring site that could be re-located in both 2007 and 2011 (**Figure 5.15**). Between December 2004 and May 2007 the channel appears to have been cleaned out creating more of a “U-shape”. There also appears to have been some slumping along the left bank during that time period. The shape does not seem to have changed significantly between May 2007 and September 2011. The left bank has eroded to create a gentler bank profile, while the right bank has remained relatively stable.

Figure 5.14: Example photographs for monitoring location at ND-1 (Dec 2004).

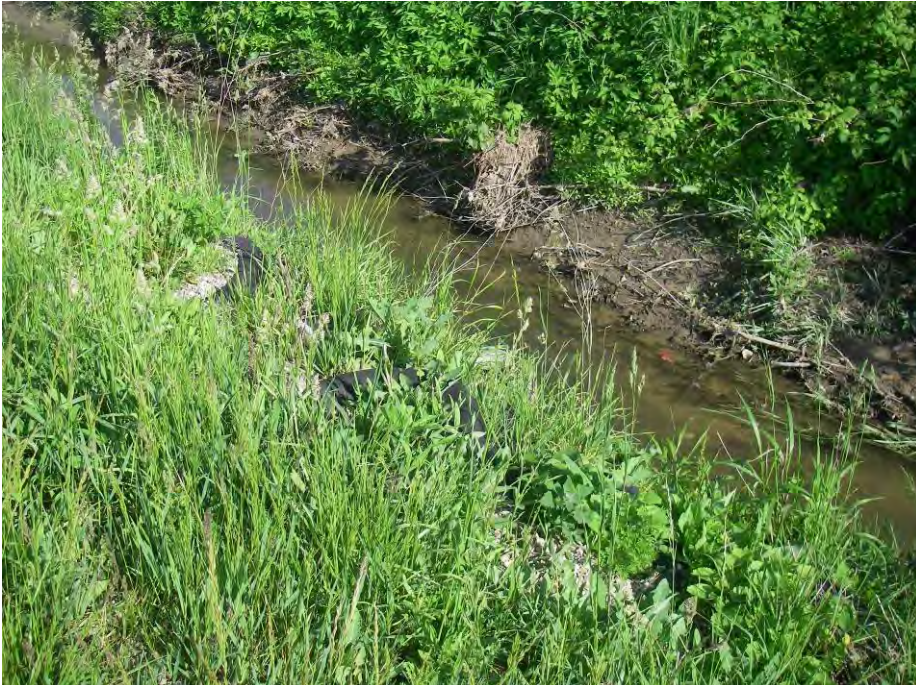
Sixth Concession (SCD-1)
Looking downstream at right bank toe erosion

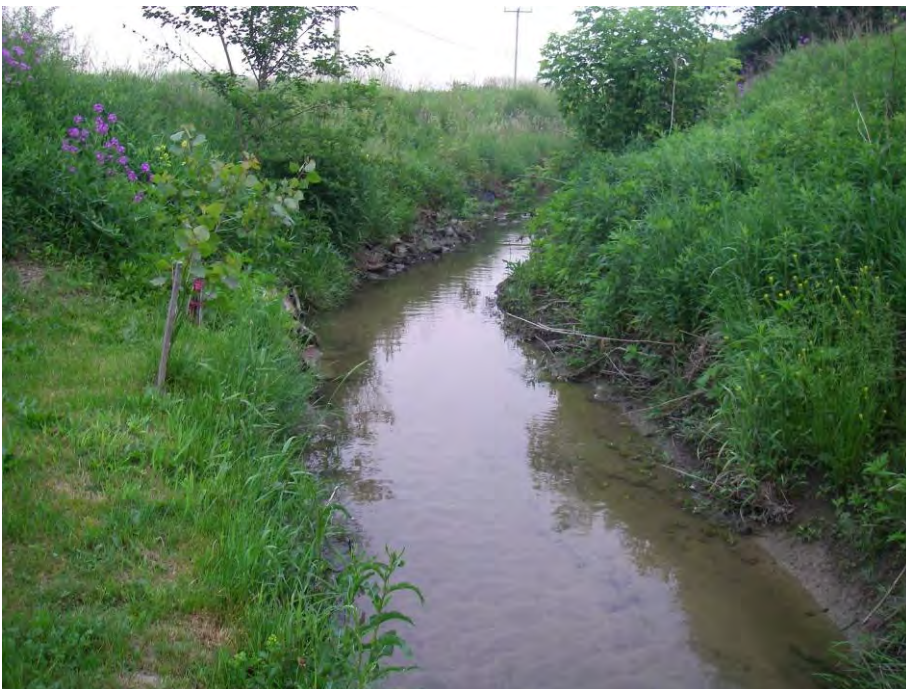
Sixth Concession (SCD-2)
Looking downstream at reach break and bank

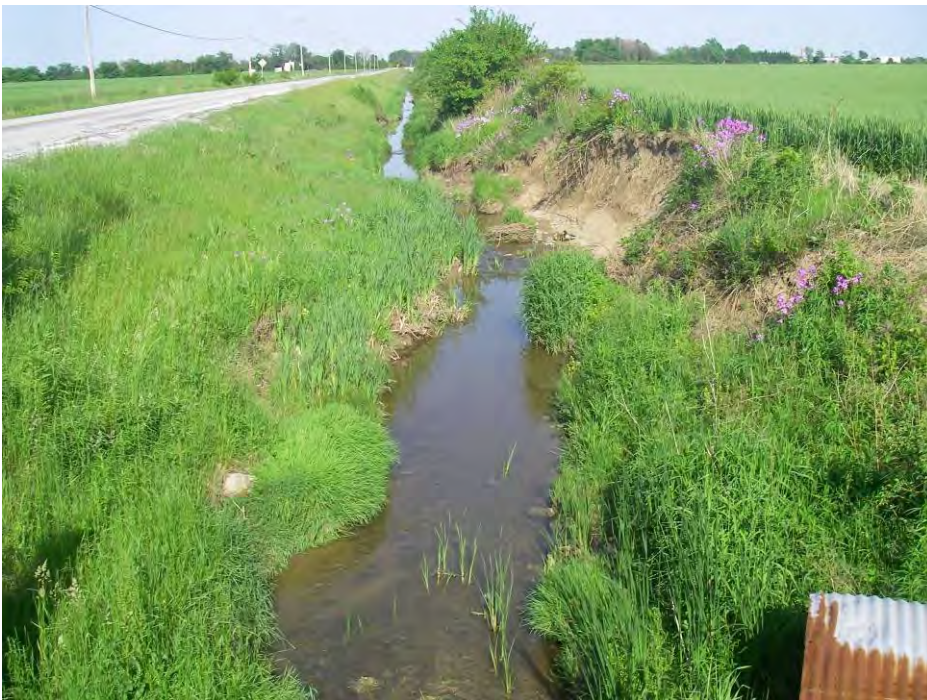
Baseline Road Drain (BRD-1)
Looking downstream from end of reach at bank erosion

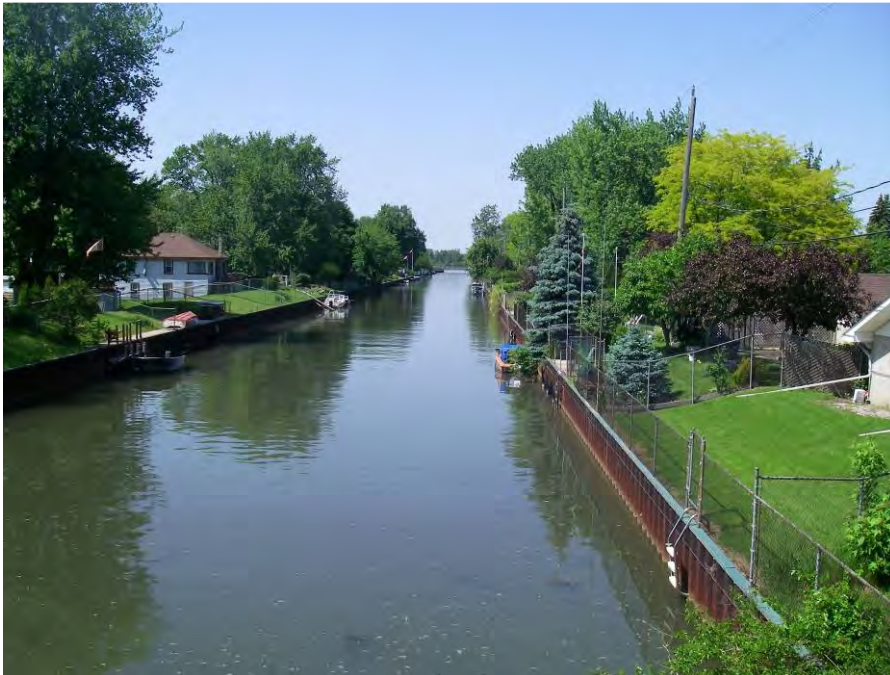
Little River Reach (LR-1)
Looking downstream at retaining walls

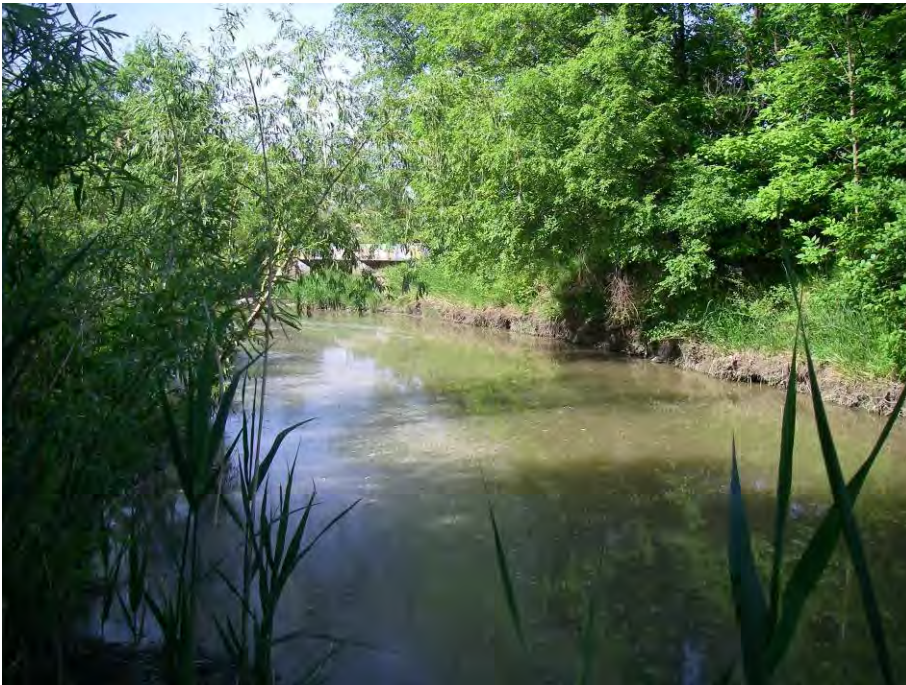
Little River Reach (LR-3)
Looking at downstream end of reach at toe erosion of right bank

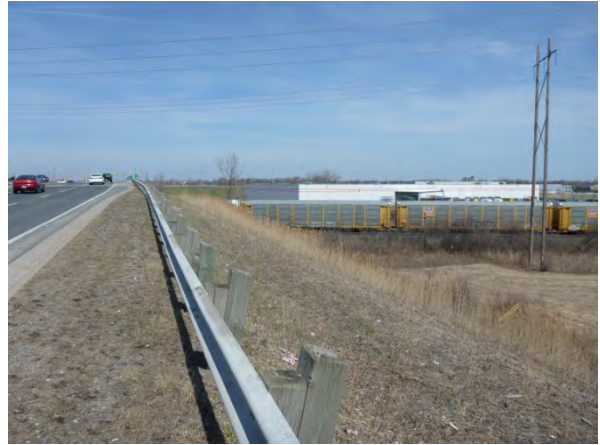
Photo 14: Intersection of Lauzon Parkway and the railway, facing north

Photos 14 - 16 depict the Windsor Subdivision of the Canadian Pacific Railway running east - west across the northern portion of the study area. Although this railway is a historic transportation route, having been completed in 1890, and appearing on McPhillips' 1898 *Plan of the Township of Sandwich* (McPhillips 1898), previous disturbance due to maintenance and expansion designates it an area of low archaeological potential.

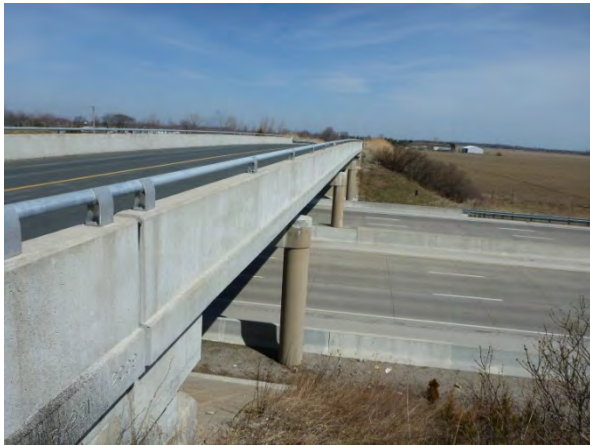
Photo 17: Concession Road 9 and Highway 401 with Municipal ROW in the background, facing north

Photos 17 - 19 provide examples of the various paved roads that cross the Study Area as well as their associated right-of-ways and culvert systems. As per Section 2.1, Standard 2b of the *Standards and Guidelines for Consultant Archaeologists* (Government of Ontario 2011) these areas have also been evaluated as having low potential due to deep land alteration that has severely damaged the integrity of archaeological resources and as such, Stage 2 survey is not required.

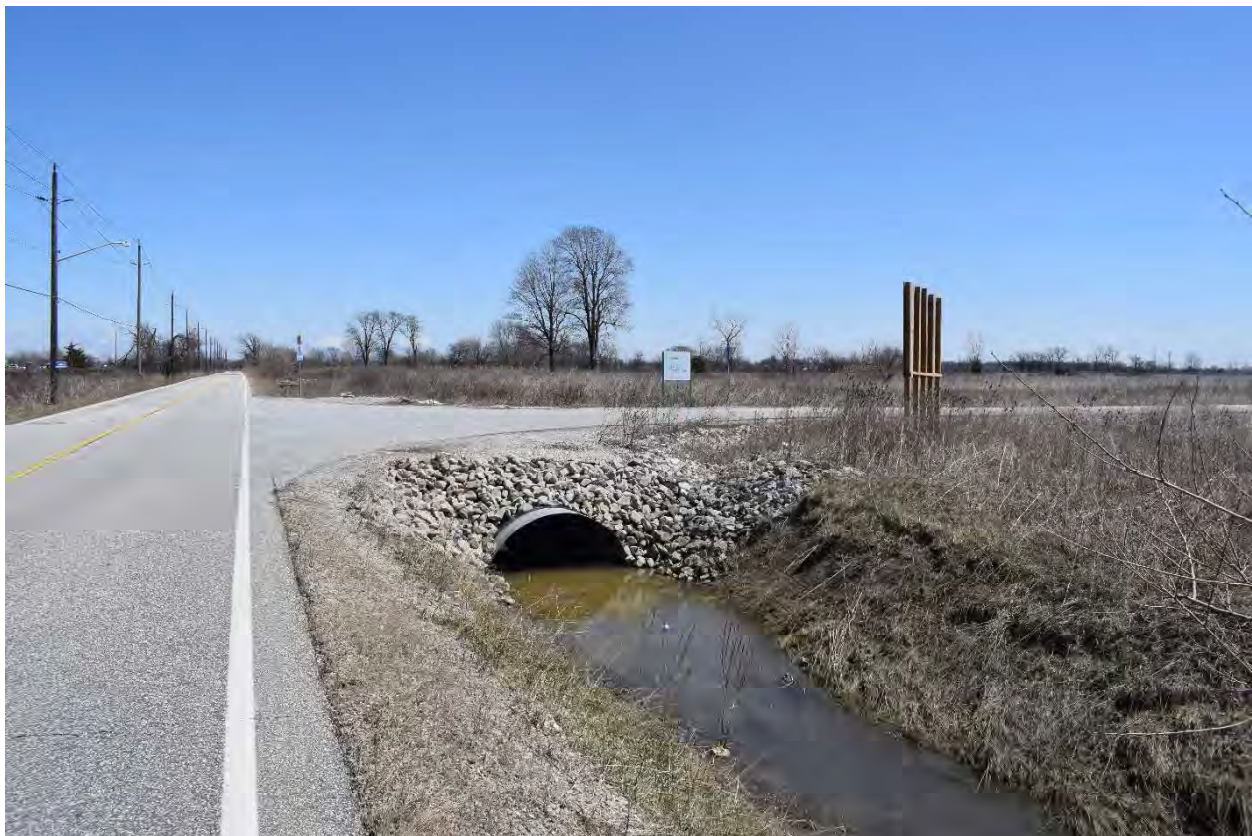
Plate 1: Deep ditch and culvert driveway example on EC Row Avenue East

The majority of the region has a history of poor drainage, which required the installation of dredged ditches and tile underdrains to have satisfactory conditions for crop growth and tillage (Chapman and Putnam 1984: 149). The issue of drainage was addressed beginning in 1869 with the first *Ontario Drainage Act*. The act provided municipal and provincial funding to land owners for the construction of drains in southwestern Ontario (Burr 2014: 22). Throughout the late 19th to the early 20th century new innovations established effective drainage throughout the county to facilitate improved agriculture. Still seen on the landscape today within the Study Area are deep ditches, with large culverts as part of driveways (Plate 1). There are also several different drains within the Study Area, including for example the Little River Drain which crosses Baseline Road (Plate 2).

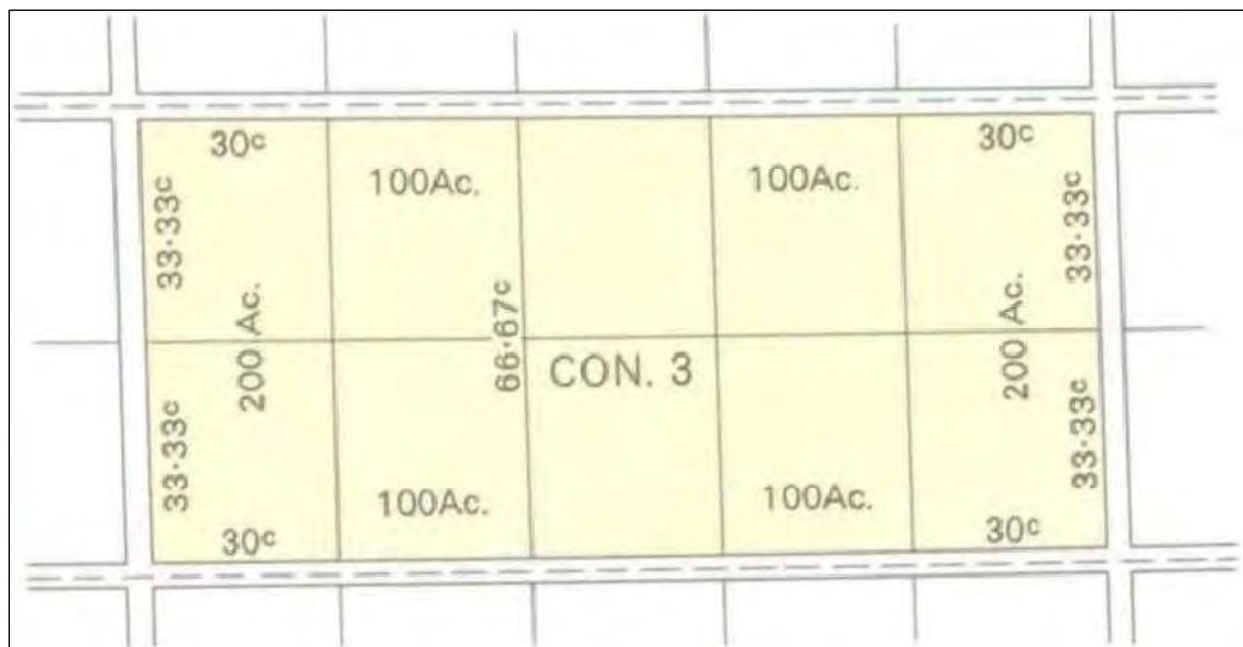
Plate 3: Double-Front Survey System (Dean 1969)

Petite Cote, the township has long narrow lots, while the remaining south and east portions of the township utilize the double-front survey system. This survey system created a rectangular pattern of 100-acre lot allowances surrounded by road allowances (Plate 3).

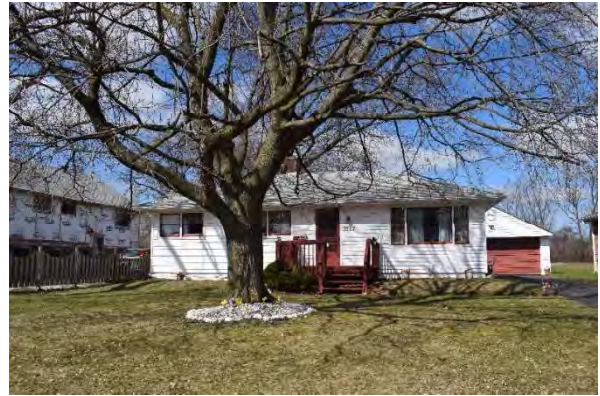
Description: The property contains a residence and a detached garage. The one storey structure has a low-pitched hip roof with asphalt shingles and a brick chimney. The residence is clad in vinyl siding and has 1/1 windows and a flat fixed wood window. The front entrance has a partial wood porch. The structure has a concrete foundation.

The residence sits on a large lot and has a mature maple tree on its front yard.

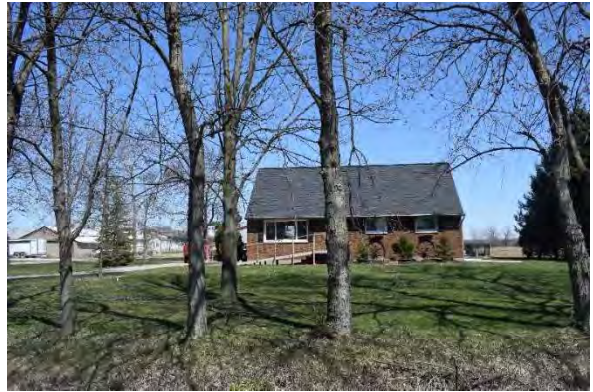
Municipal Address: 3780 Lauzon Road
Former Township: Township of Sandwich
Municipality: City of Windsor
Resource Type: Farmstead
Associated Dates: 1962-1975

Description: The property contains a residence and several outbuildings. The residence is a one storey structure with a high-pitched side gable roof with asphalt shingles. The structure has a brick exterior with modern windows. The entrance has a partial brick and concrete porch. The residence has a concrete foundation.

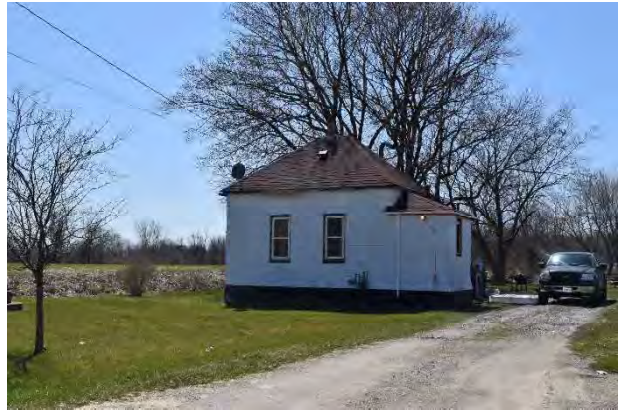
Municipal Address: 3805 Lauzon Road
Former Township or County: Township of Sandwich
Municipality: City of Windsor
Resource Type: Residence
Associated Dates: 1932-1940
Relationship to Project: Within the Study Area

Description: The property contains a laneway and a residence. The one storey structure has a high-pitched hip roof with asphalt shingles, and a central chimney. The exterior is clad in vinyl siding and has modern windows. The structure has a salt box side, and an undetermined foundation.

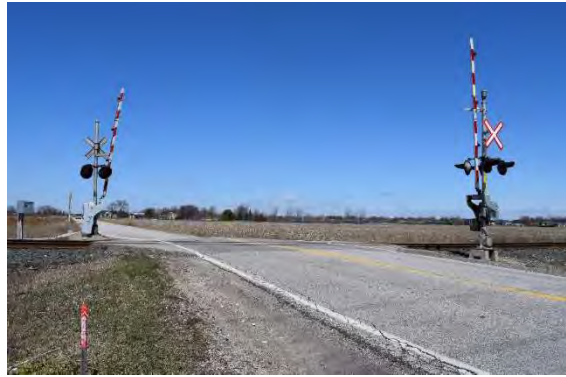
Municipal Address: Banwell Road
Former Township: Township of Sandwich
Municipality: City of Windsor/Town of Tecumseh
Resource Type: Railway Line
Associated Dates: 1853
Relationship to Project: Within the Study Area

Description: The property contains the former Great Western Railway Line, now part of the Canadian National (CN) Railway.

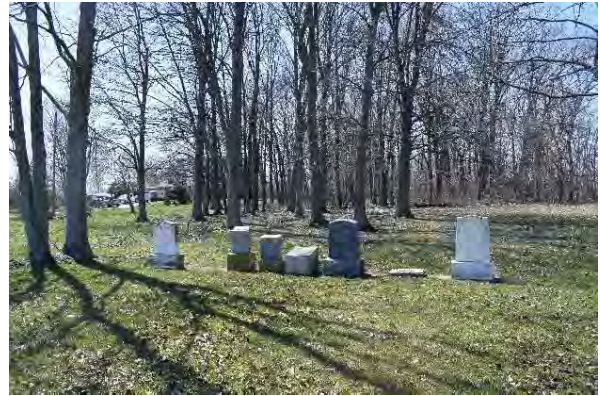
Description: The property contains the Banwell Road Black Cemetery. The cemetery has six grave markers that date to the early 20th century. The cemetery contains the graves of early black settlers to the Township of Sandwich, including those associated with the Underground Railroad. The property has a provincial plaque that marks the significance of The Banwell Road Area Black Settlement.

The property is designated under Part IV of the *Ontario Heritage Act* by the Town of Tecumseh.

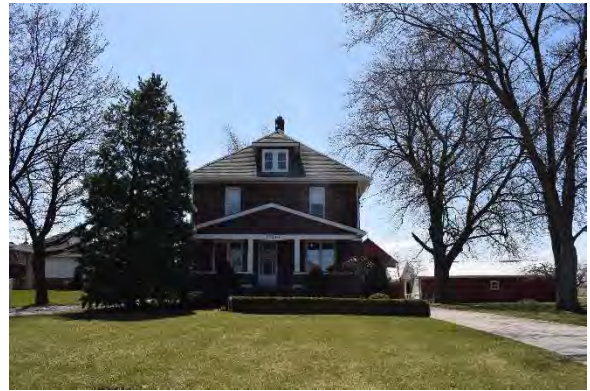
The residence is a two storey structure with a high-pitched hip roof with asphalt shingles and a brick chimney. The front (north) elevation has a central hip dormer. The structure has a symmetrical red brick exterior. The front elevation has a covered full width porch that is clad in stone and has brick piers. The upper exterior has 3/1 wood windows. The residence has a stone foundation.

At the rear of the residence is a timber frame barn with a side gable roof that is clad in metal. The property has a tree-lined laneway, and mature maple and white pine trees.

Identified Heritage Attributes: Residence: Two storey structure, high-pitched hip roof, brick chimney, hip dormer, symmetrical exterior, red brick exterior, covered full width porch, 3/1 wood windows, and stone foundation. Barn: Timber frame structure and side gable roof. Landscape: Tree-lined laneway, mature maple and white pines.

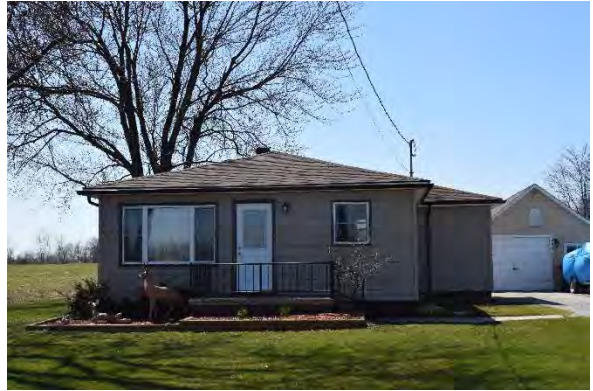
Municipal Address: 3945 Lauzon Road
Former Township: Township of Sandwich
Municipality: City of Windsor
Resource Type: Residence
Associated Dates: 1940-1961

Description: The property contains a residence and a detached modern garage.

The residence is a one storey structure with a low-pitched hip roof with asphalt shingles. The structure has an asymmetrical exterior with vinyl cladding. The residence has modern windows and doors, and a concrete foundation. The property has a mature maple tree.

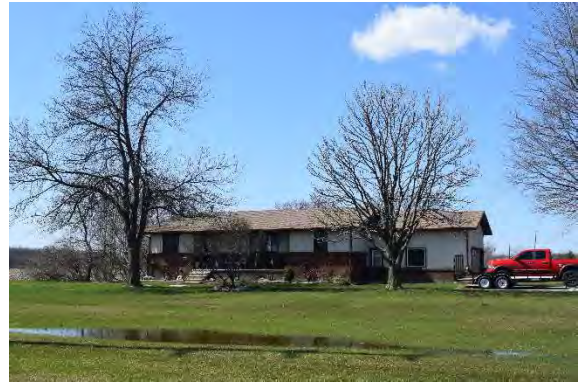
Description: The property contains a residence.

The residence is a one storey structure with a low-pitched side gable roof with asphalt shingles. The asymmetrical exterior is clad in vinyl siding and brick. The residence has modern windows and doors, and an attached single-car garage. The structure has a concrete foundation.

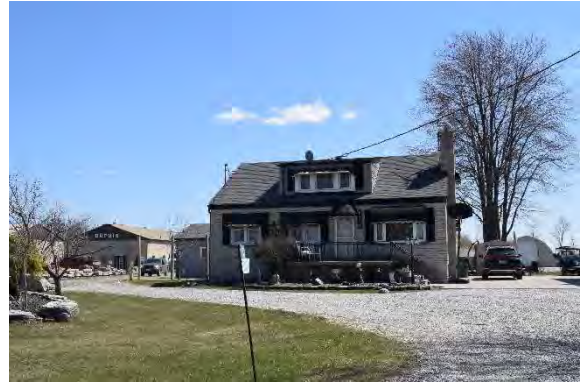
Description: The property contains a residence that is situated on a commercial property, "Frank Dupuis Landscaping & Trucking Ltd." The residence is possibly used as commercial offices. The property contains modern outbuildings associated with the commercial business.

The residence is a one and a half storey structure with a medium-pitched side gable roof that has asphalt shingles and a concrete block chimney. The front (north) elevation has a shed dormer. The structure is clad in brick and has modern windows. The front elevation has a partial brick and concrete porch with metal railing. The structure has a concrete block foundation.

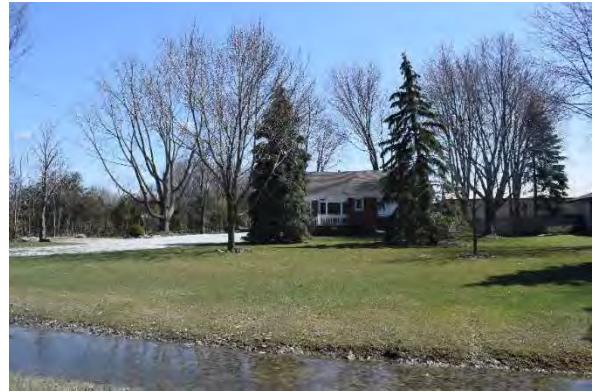
Description: The property contains a residence, and mature spruce and maple trees.

The residence is a one storey structure with a low-pitched side gable roof with asphalt shingles. The exterior is clad in brick and has modern windows and doors. The front (north) entrance has a partial concrete porch clad in brick. The structure has a concrete foundation.

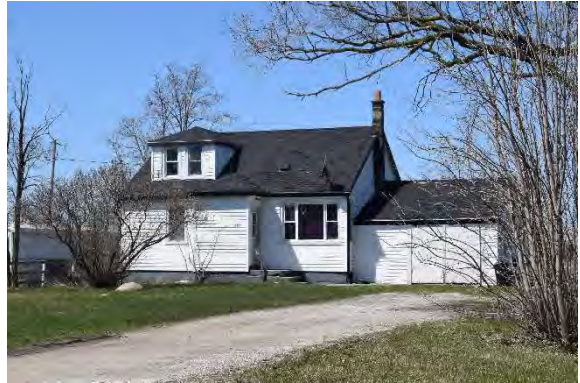
Description: The property contains a residence. The property is bordered by a wood fence.

The residence is a one and a half storey structure with a medium-pitched side gable roof with asphalt shingles and a brick chimney. The front (south) elevation has a hip dormer. The structure is clad in vinyl siding and has modern windows and doors. The structure has a concrete block foundation.

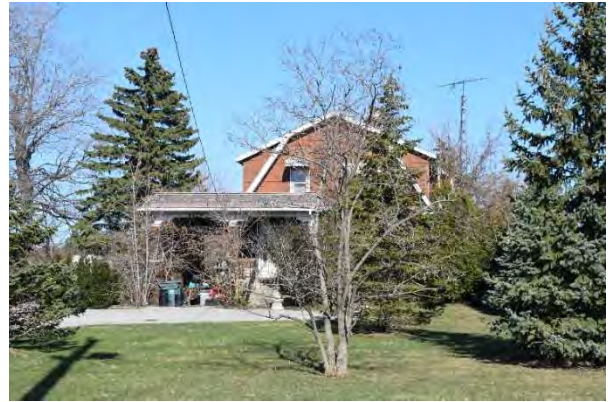
Description: The property contains a residence and outbuilding. The property has mature deciduous and coniferous trees.

The residence is a one and a half storey structure and has a medium-pitched gambrel roof with a brick chimney. The north and south roof elevations have large shed dormers. The exterior is clad in vinyl siding and has modern windows. The entrance has a covered partial porch with concrete steps and brick piers. The structure has an undetermined foundation.

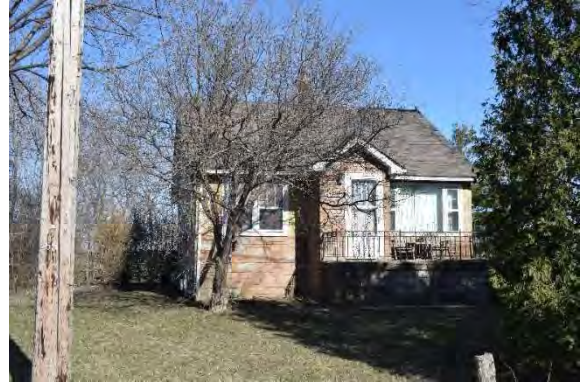
Description: The property contains a laneway and residence.

The residence is a one storey structure with a high-pitched side gable roof with asphalt shingles and a brick chimney. The exterior is clad in stone and has modern windows. The structure has a projecting entrance with a partial concrete porch that is clad in stone and has a metal railing. The foundation is undetermined.

The residence is situated behind a cedar hedge and the property has mature deciduous trees.

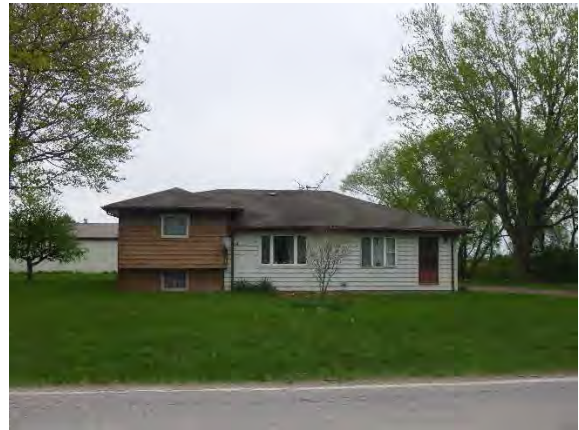
The residence is one storey structure with a low-pitched hip roof with asphalt shingles. The exterior is clad in vinyl siding and has modern windows and doors. The structure appears to have a north addition. The residence has a concrete foundation.

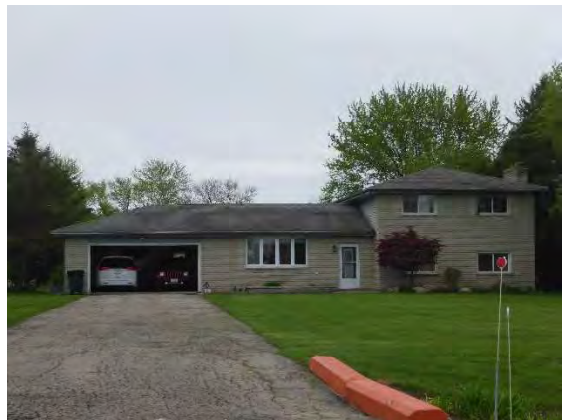
The residence is a one and a half storey structure with a low-pitched side gable roof. The structure is clad in brick and has modern windows and doors. The residence has a single-car garage.

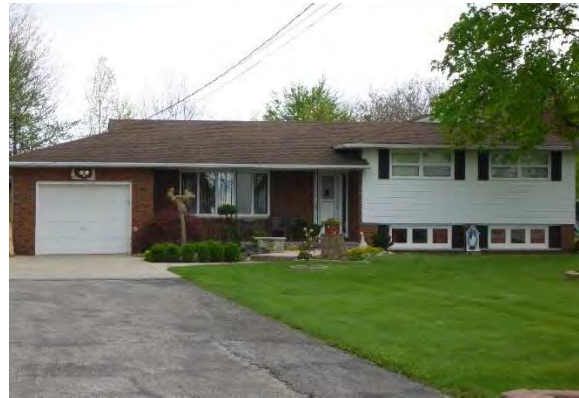
The residence is a one and a half storey structure with a low-pitched hip roof with asphalt shingles. The structure is clad in brick and vinyl siding and has modern windows and doors. The split-level residence has a single-car garage.

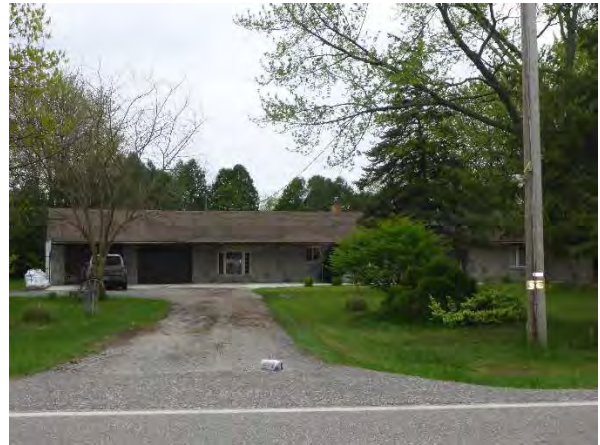
The residence is a one storey structure with a low-pitched side gable roof with asphalt shingles and a brick chimney. The structure is clad in stone and has modern windows and doors. The residence has an attached double-car garage.

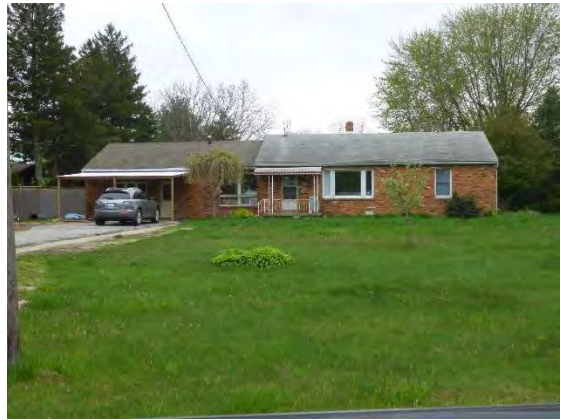
The residence is a one storey structure with a low-pitched side gable roof with asphalt shingles and a brick chimney. The structure is clad in brick and has modern windows and doors. The residence has a covered partial porch and a single-car garage.

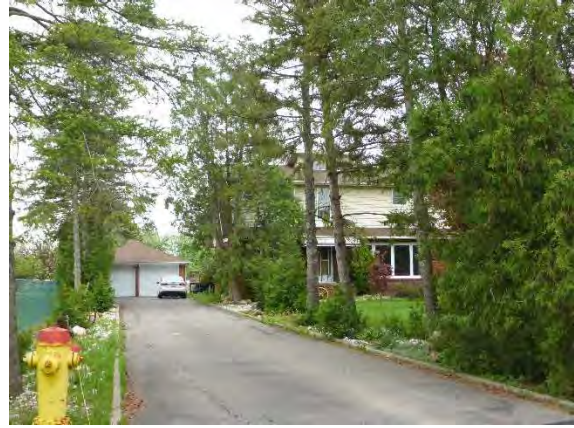
Description: The property contains a residence and a detached double-car garage. The view of the residence is obstructed by vegetation.

The residence is a two storey structure with a low-pitched side gable roof. The front (north) elevation has a shed dormer. The structure is clad in vinyl siding and brick and has modern windows and doors. The front elevation has a partial porch clad in brick with a metal railing. The structure has an undetermined foundation.

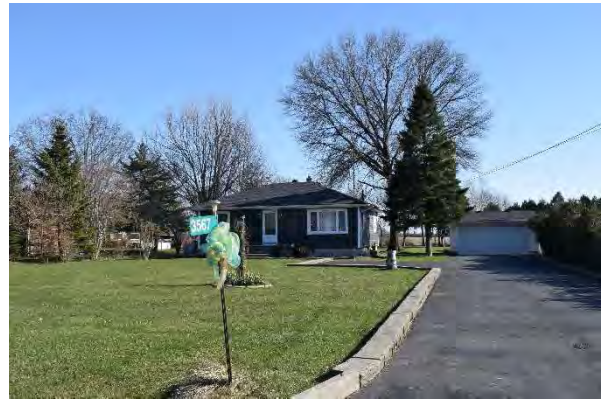
The residence is a one storey structure with a medium-pitched hip roof with asphalt shingles and a chimney. The structure is clad in vinyl siding and has modern windows and doors. The residence has a covered partial concrete porch and a concrete foundation.

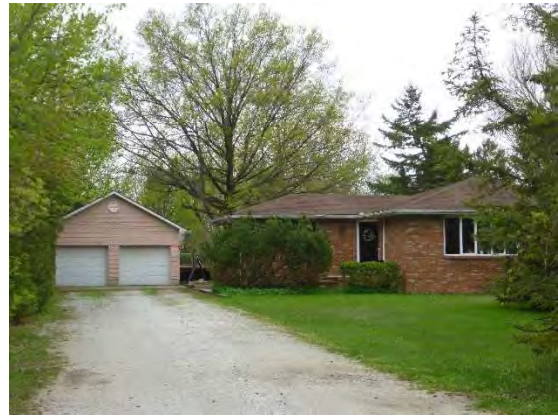
The residence is a one storey structure with a low-pitched hip roof with asphalt shingles. The structure is clad in brick and has modern windows and doors. The structure has a concrete foundation.

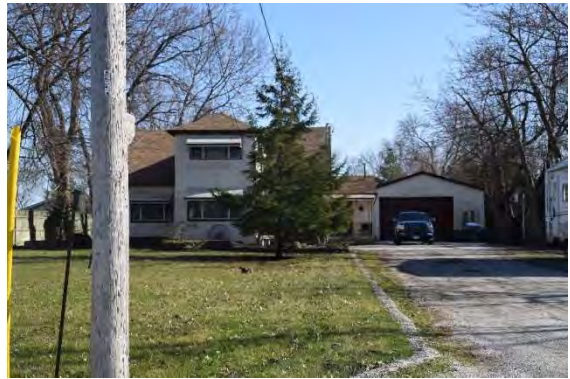
The residence is a one and a half storey structure with a low-pitched side gable roof with asphalt shingles and a brick chimney. The structure is clad in vinyl siding and has modern windows and doors. The front (north) elevation has a central projecting bay, and a covered partial porch. The side (west) elevation has a projecting entrance.

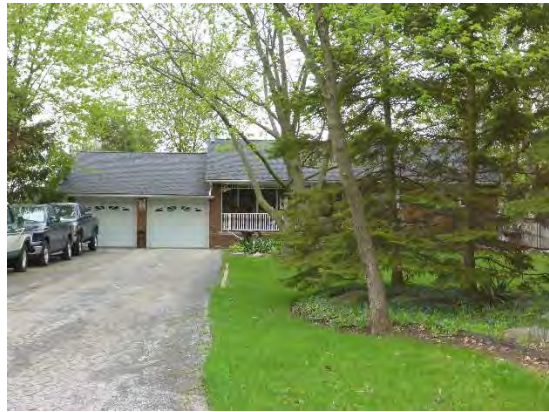
Municipal Address: 3665 Baseline Road
Former Township: Township of Sandwich
Municipality: City of Windsor
Resource Type: Residence
Associated Dates: 1962-1975

The residence is a one storey structure with a low-pitched side gable roof with asphalt shingles. The structure is clad in brick and has modern windows and doors. The residence has an attached double-car garage. The structure has an undetermined foundation.

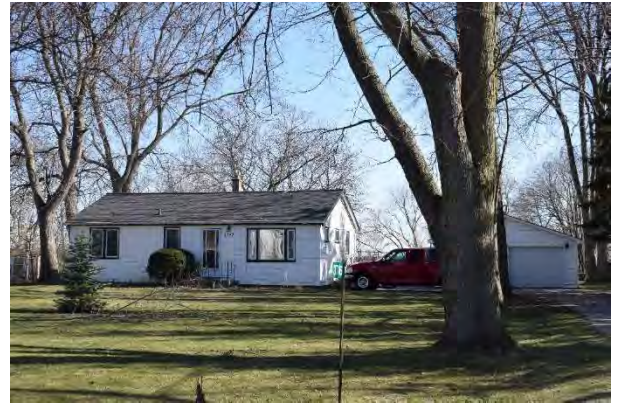
The residence is a one storey structure with a low-pitched side gable roof with asphalt shingles and a concrete chimney. The structure is clad in vinyl siding and has modern windows and doors. The residence has a partial concrete porch and an undetermined foundation.

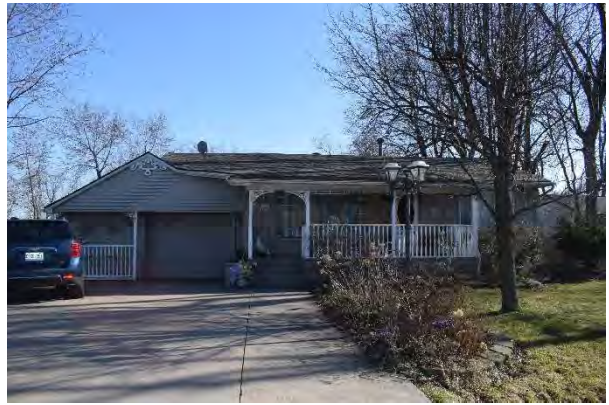
Municipal Address: 3765 Baseline Road
Former Township: Township of Sandwich
Municipality: City of Windsor
Resource Type: Residence
Associated Dates: 1962-1975

The residence is a one storey structure with a low-pitched side gable roof with asphalt shingles. The structure is clad in vinyl siding and has modern windows and doors. The front (north) elevation has a covered partial wood porch. The structure has an attached single-car garage and a concrete foundation.

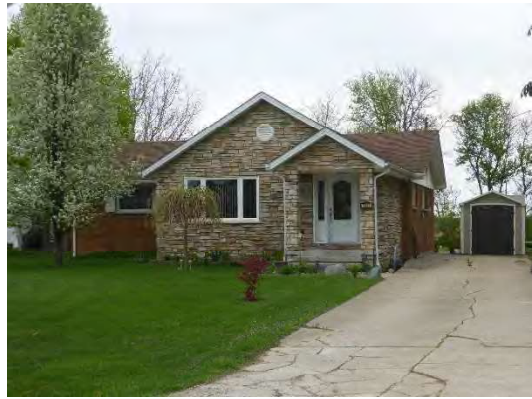
Municipal Address: 3825 Baseline Road
Former Township: Township of Sandwich
Municipality: City of Windsor
Resource Type: Residence
Associated Dates: 1962-1975

The residence is a one storey structure with a medium-pitched cross gable roof with asphalt shingles. The structure is clad in brick and stone and has modern windows and doors. The front (north) elevation has a modern addition that has a covered partial concrete entry porch. The structure has a concrete foundation.

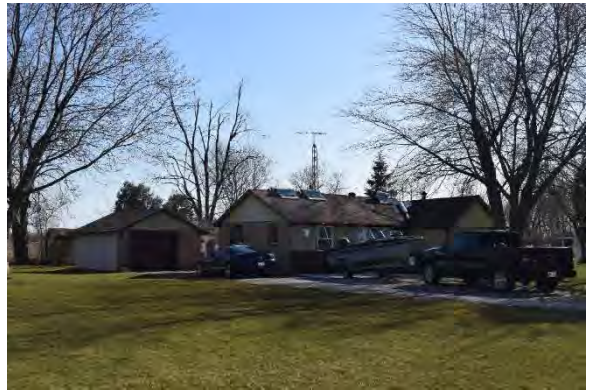
The residence is a one storey structure with a medium-pitched cross gable roof with asphalt shingles. The structure is clad in brick and aluminum siding and has modern windows and doors. The residence has a concrete foundation.

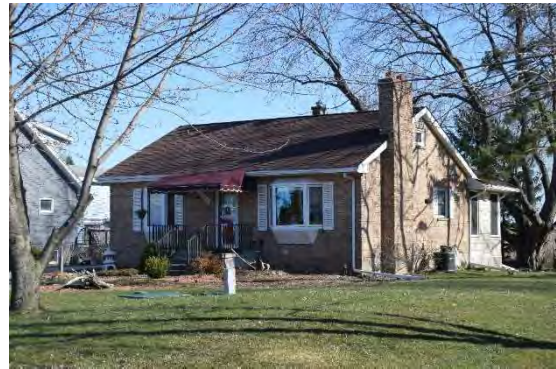
The residence is a one storey structure with a medium-pitched side gable roof with asphalt shingles and a brick chimney. The structure is clad in brick and has modern windows and doors. The residence has a partial concrete porch and a concrete foundation.

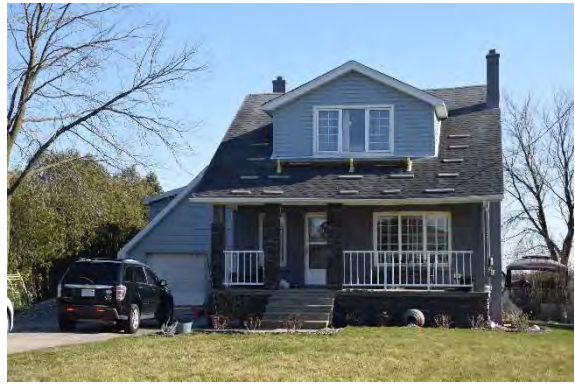
The residence is a one and a half storey structure with a medium-pitched side gable roof with asphalt shingles and two concrete chimneys. The front (north) elevation has a central gabled dormer. The structure is clad in brick and has modern windows and doors. The front elevation has a covered full width concrete porch clad in brick. The residence has a concrete foundation.

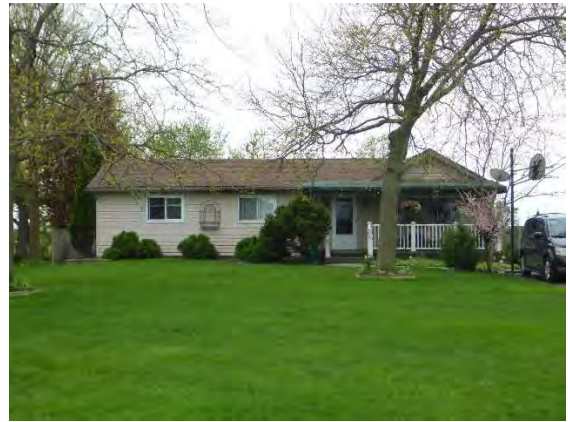
The residence is a one storey structure with a medium-pitched side gable roof with asphalt shingles and a brick chimney. The structure is clad in vinyl siding and has modern windows and doors. The front (north) elevation has a partial wood porch and a front facing gable. The structure has a concrete foundation.

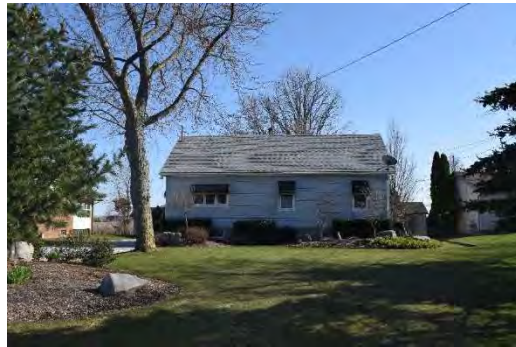
Municipal Address: 4095 Baseline Road
Former Township: Township of Sandwich
Municipality: City of Windsor
Resource Type: Residence
Associated Dates: 1962-1975

The residence is a one storey structure with a medium-pitched side gable roof with asphalt shingles. The structure is clad in vinyl siding and has modern windows and doors. The residence has a concrete foundation.

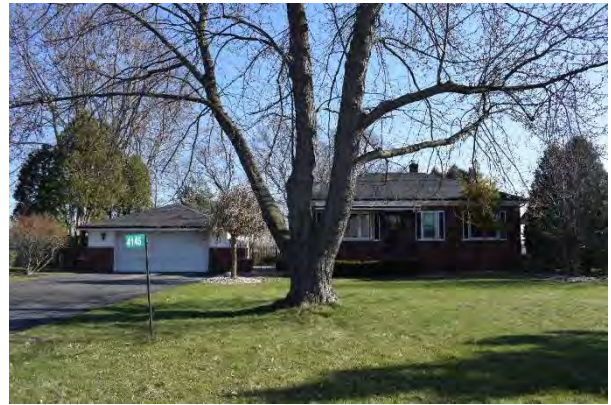
The residence is a one storey structure with a medium-pitched hip roof with asphalt shingles and a brick chimney. The structure is clad in brick and has modern windows and doors. The residence has a partial porch and a concrete foundation.
