**Monthly Water Balance Analysis
Upper Little River EA
Existing Conditions**

Monthly Water Balance Analysis
 Upper Little River EA
 Proposed Conditions

Sandwich South Employment Lands Upper Little River Existing Conditions

Document Title: Sandwich South Employment Lands –
Upper Little River Existing Conditions
Status: Draft Report
Version: 01
Date: December 2012
Project name: Sandwich South Employment Lands
Project number: 01-11-46
Client: Stantec
Reference: 01-11-46/01 - draft

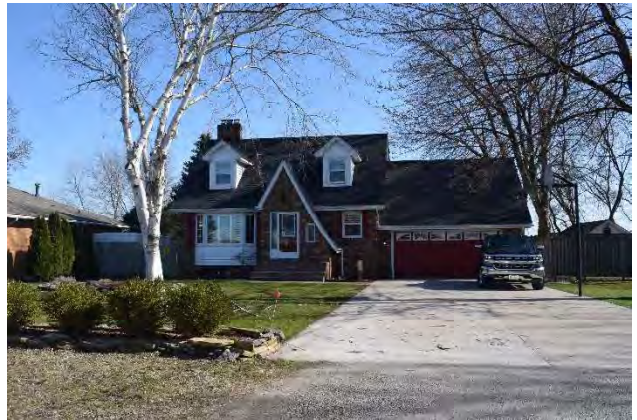
The residence is a one and a half storey structure with a medium-pitched side gable roof with asphalt shingles and a brick chimney. The front (north) elevation has two gabled dormers. The structure is clad in brick and has modern windows and doors. The front entrance has projecting entrance with an asymmetrical gable. The residence has an attached single-car garage, and a concrete foundation.

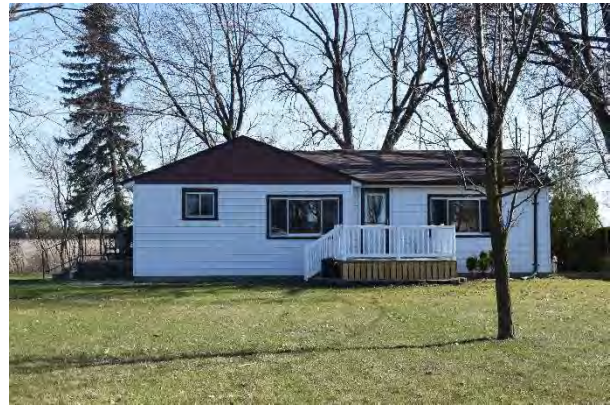
The residence is a one storey structure with a low-pitched cross gable roof with asphalt shingles. The structure is clad in vinyl siding and has modern windows and doors. The residence has a partial wood porch and a concrete foundation

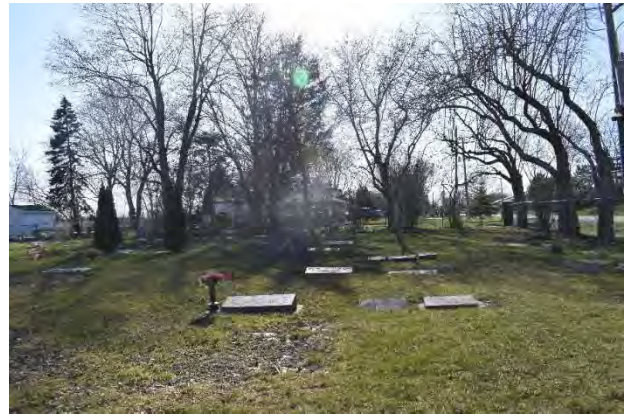
The cemetery was established in 1900. Thomas Fairbairn donated one acre of land from his farm for a cemetery, prior to his death on May 24, 1900. Thomas Fairbairn was the first burial in the cemetery.

The cemetery contains a mixture of grave markers from the early 20th century to the 21st century. The entrance to the cemetery is marked with brick piers with metal gates.

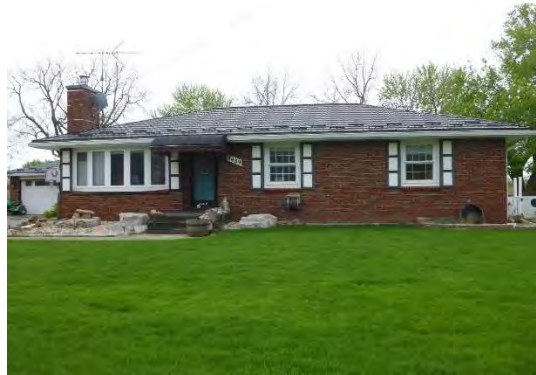
The residence is a one storey structure with a low-pitched hip roof with asphalt shingles and a brick chimney. The structure is clad in brick and has modern windows and doors. The residence has a partial concrete and porch and a concrete foundation.

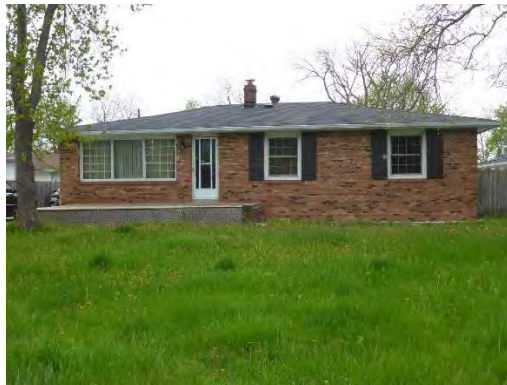
The residence is a one storey structure with a low-pitched hip roof with asphalt shingles and a brick chimney. The structure is clad in brick and has modern windows and doors. The residence has a partial wood porch and a concrete foundation.

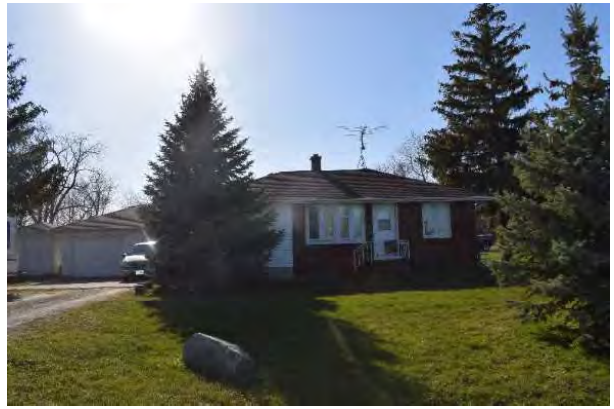
The residence is a one storey structure with a low-pitched hip roof with asphalt shingles and a brick chimney. The structure is clad in brick and has modern windows and doors. The residence has a partial concrete porch and a concrete foundation.

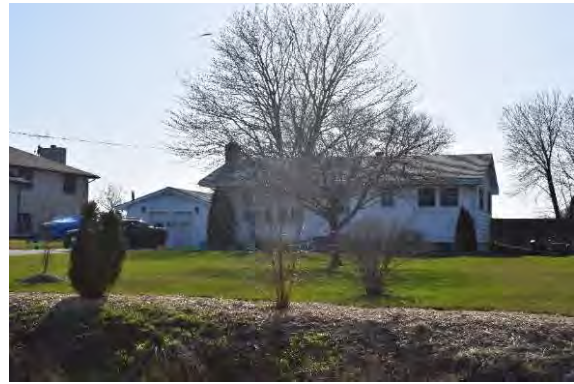
The residence is a one storey structure with a low-pitched side gable roof with asphalt shingles and a brick chimney. The structure is clad in vinyl siding and has modern windows and doors. The residence has a partial concrete porch and a concrete foundation.

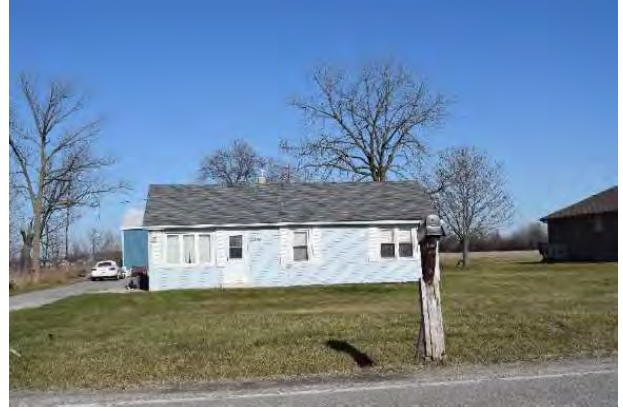
The residence is a one storey structure with a low-pitched side gable roof with asphalt shingles and a concrete chimney. The structure is clad in vinyl siding and has modern windows and doors. The residence has a partial concrete porch and an undetermined foundation.

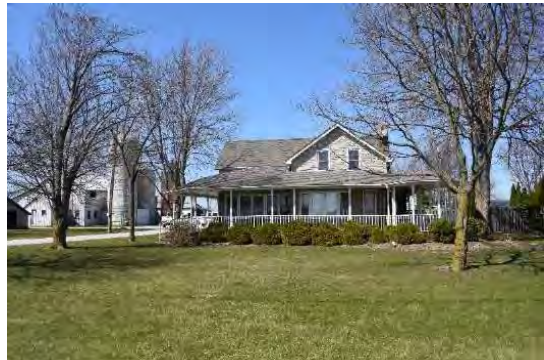
The circa 1875 residence is a one and a half storey structure with a medium-pitched cross gable roof with asphalt shingles and a brick chimney. The structure has a T-shaped plan, with a covered wraparound verandah. The exterior is clad in vinyl siding and has modern windows and doors. The foundation was not visible from the roadway.

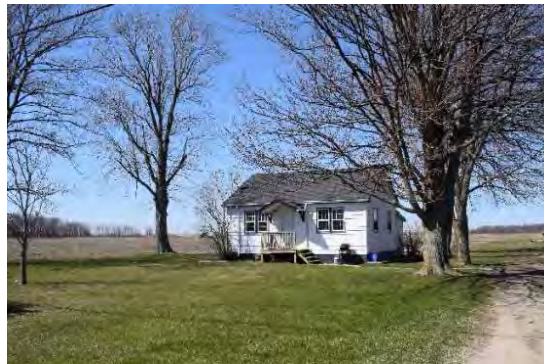
The second residence, that dates between 1962 and 1975, is a one storey structure with a medium-pitched side gable roof with asphalt shingles. The exterior is clad in vinyl siding and has modern windows and doors. The residence has partial wood entrance porch, an entrance gable, and a concrete foundation.

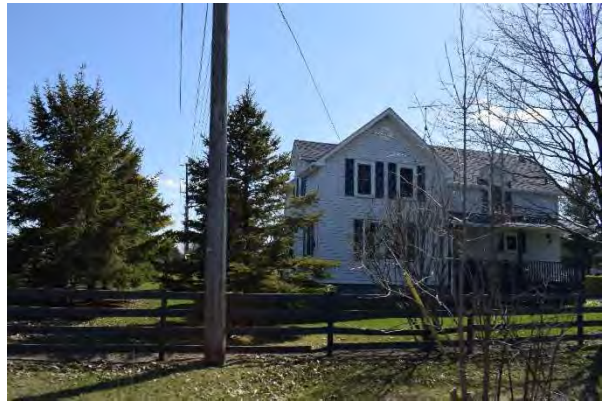
The residence is a one and a half storey structure with a medium-pitched cross gable roof with asphalt shingles. The roofline has two gabled dormers. The residence has a T-shaped plan. The exterior is clad in vinyl siding and has modern windows and doors. The north elevation has a covered partial wood porch. The structure has a rusticated concrete foundation.

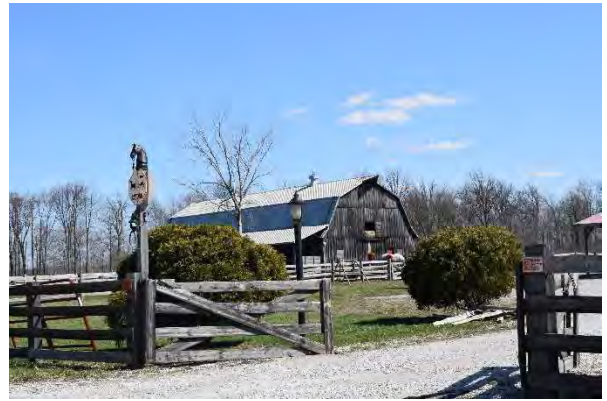
The barn is a timber frame structure with a gambrel roof that is clad in metal and has hay hoods and two ventilators. The outbuilding is a timber frame structure with a side gable roof that is clad in metal.

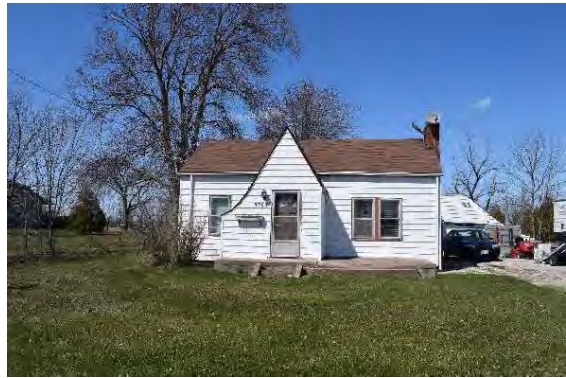
The residence is a one storey structure with a medium-pitched side gable roof with asphalt shingles and a brick chimney. The structure is clad in vinyl siding and has 1/1 metal windows. The front (south) elevation has projecting entry porch with an asymmetrical gable. The residence has a partial concrete porch and a concrete foundation. The structure has a rear addition with an attached single-car garage.

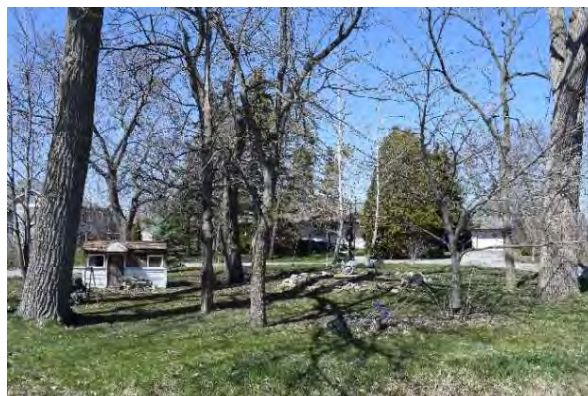
The residence is a one storey structure with a low-pitched side gable roof with asphalt shingles. The structure is clad in vinyl siding and has modern windows and doors. The residence has an undetermined foundation.

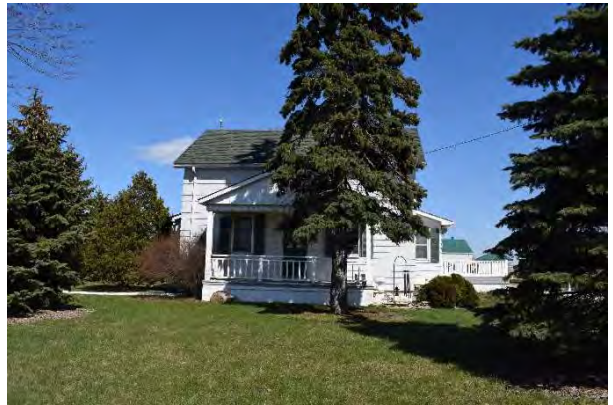
The residence is a one and a half storey structure with a medium-pitch side gable roof with asphalt shingles. The structure is clad in vinyl siding and has modern windows and doors. The front (west) three-bay façade has a covered partial wood porch. The residence has a south entry porch addition and a stone foundation.

Identified Heritage Attributes: Residence: One and a half storey structure, medium-pitched side gable roof, three-bay front façade, and stone foundation. Landscape: mature spruce trees.

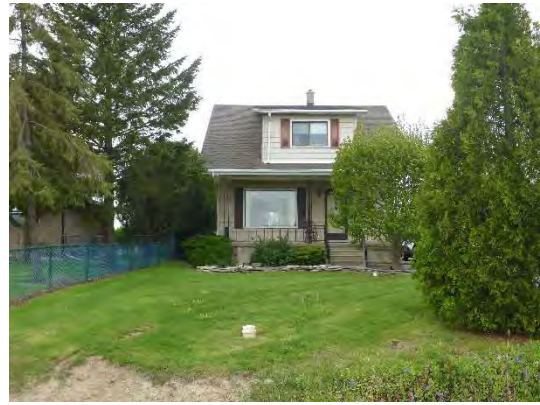
The residence is a one and a half storey structure with a medium-pitched side gable roof and concrete chimney. The front (east) elevation has a shed dormer. The structure is clad in vinyl siding and has modern windows and doors. The front elevation has a full width concrete porch with metal railings. The structure has a concrete foundation.

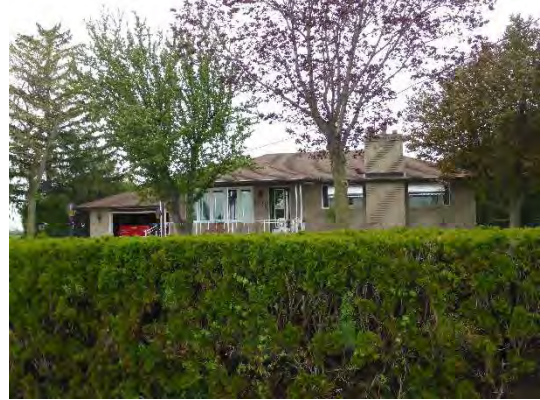
The residence is a one storey structure with a medium-pitched hip roof with brick chimney. The structure is clad in brick and has modern windows and doors. The front (east) elevation has a partial concrete porch. The structure has a concrete foundation.

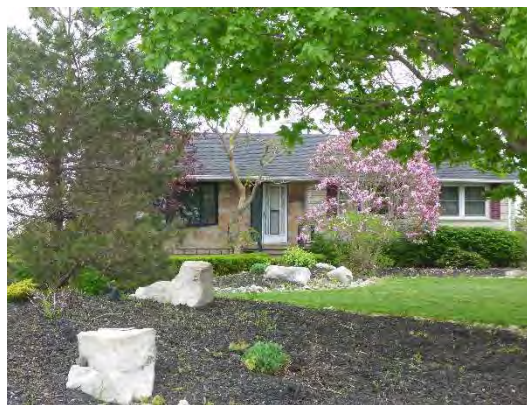
The residence is a one storey structure with a medium-pitched side gable roof with asphalt shingles and a brick chimney. The structure is clad in brick and stone and has modern windows and doors. The front (west) elevation has a partial concrete porch with metal railings. The structure has a concrete foundation and an attached single-car garage.

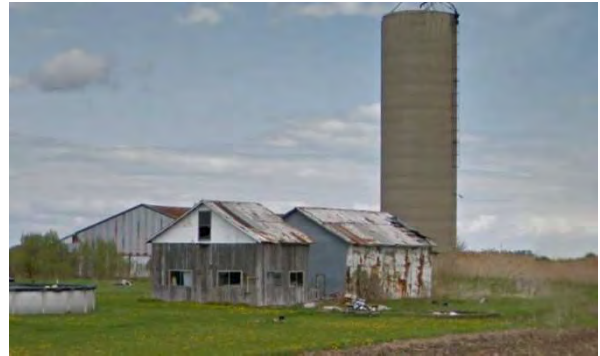
The largest outbuilding has a side gable roof and is clad in metal. Attached to the outbuilding is the concrete silo. Adjacent to the outbuilding and silo, are two smaller outbuildings with side gable roofs. One has vertical wood boards, the other is clad in metal.

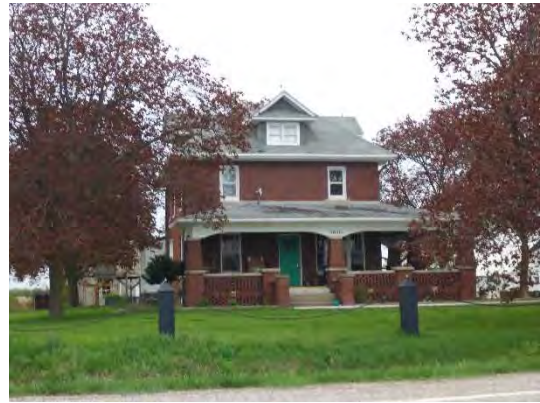
The residence is a two and a half storey structure with a medium-pitched hip roof with asphalt shingles. The roofline has three gabled dormers. The structure has a red brick exterior. The majority of windows are modern except for some 4/1 and 3/1 windows on the lower storey. The residence has a covered wraparound brick, concrete, and wood verandah. The front (east) entrance has a wood paneled door. The structure has an undetermined foundation.

The residence is listed on the City of Windsor's Municipal Heritage Register. It is recognized as the John Hayes House.

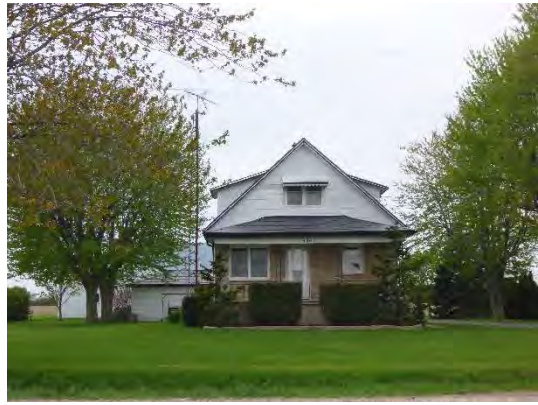
The residence is a one and a half storey structure with a medium-pitched front facing gable roof and a brick chimney. The north and south elevations have shed dormers. The exterior is clad in vinyl siding and stone and has modern windows and doors. The front (east)

elevation has a covered full width concrete porch with metal railings. The foundation was undetermined.

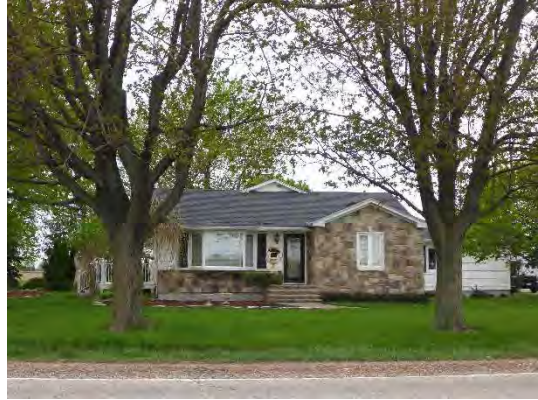
Description: The property contains a residence and a modern garage.

The residence is a one storey structure with a cross gable roof that has asphalt shingles. The structure is clad in stone and vinyl siding and has modern windows and doors. The residence has a concrete foundation.

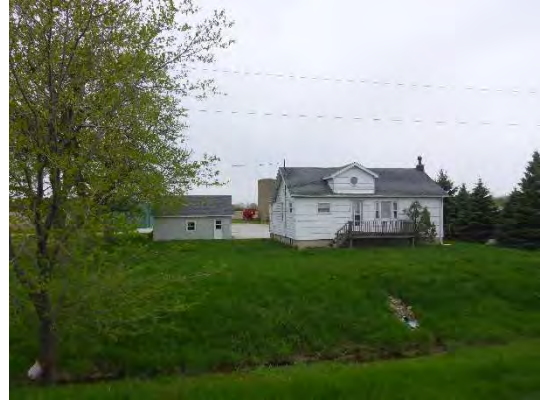
Description: The property contains a residence, two outbuildings and a concrete silo.

The residence is a one storey structure with a medium-pitched side gable roof with asphalt shingles and a brick chimney. The east elevation has a gabled dormer. The structure is clad in vinyl siding and has modern windows and doors. The residence has a concrete foundation.

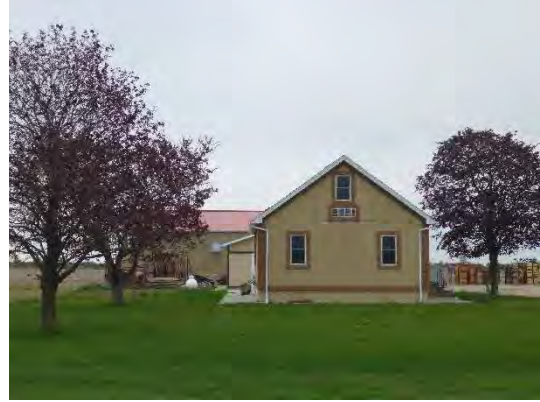
Description: The property contains a residence, a modern garage, and modern outbuilding.

The residence is a one and a half storey structure with a medium-pitched side gable roof with asphalt shingles and a stucco clad chimney. The exterior is clad in stucco and has modern windows and doors. The front (south) elevation has a partial concrete porch. The structure has a concrete foundation.

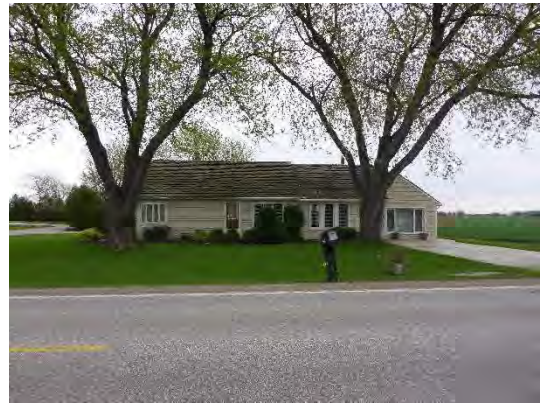
Description: The property contains a residence and a modern garage.

The residence is a one storey structure with a medium-pitched side gable roof. The structure is clad in vinyl siding and has modern windows and doors. The residence has a concrete foundation.

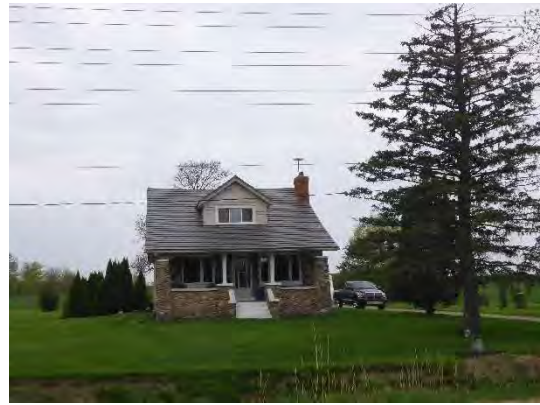
Description: The property contains a residence.

The residence is a one and a half storey structure with a medium-pitched side gable roof with metal shingles and a brick chimney. The front (east) elevation has a gabled dormer. The structure is clad in stone and has modern windows and doors. The three-bay front façade has a covered full width concrete porch that is clad in stone. The structure has a concrete foundation.

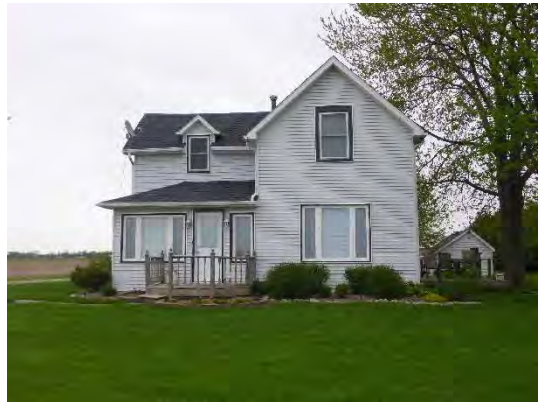
Description: The property contains a residence and two outbuildings.

The residence is a one and a half storey structure with a cross gable roof with asphalt shingles. The structure has a T-shaped plan. The exterior is clad in vinyl siding and has modern windows and doors. The front (west) elevation has an enclosed partial porch and a gabled dormer. The residence has an undetermined foundation.

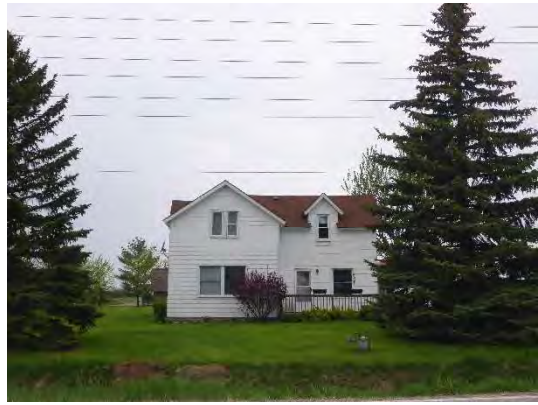
The front (east) elevation has a partial wood porch. The residence has a rusticated concrete foundation.

At the rear of the property is a vertical wood outbuilding with a side gable roof that is clad with metal.

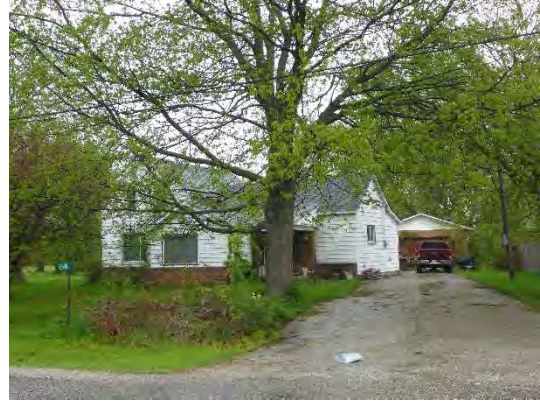
The residence is a one and a half storey structure with a medium-pitched cross gable roof with asphalt shingles. The structure has a T-shaped plan, with a front (south) one storey addition. The residence is clad in vinyl siding and brick and has modern windows and doors. The structure has a concrete foundation.

The single-car garage to the rear of the residence is a one storey structure with a gable roof. Its exterior is clad in brick and vinyl siding.

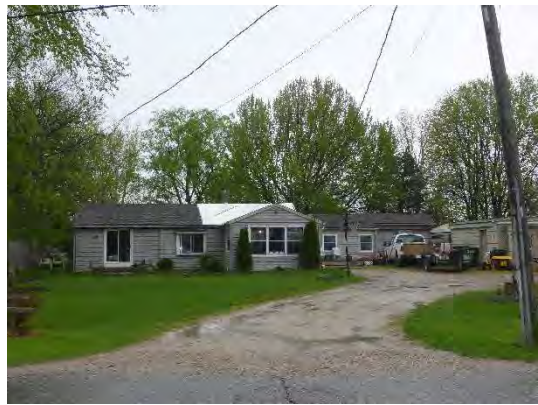
Description: The property contains a residence and a detached garage.

The residence is a one storey structure with a medium-pitched side gable roof with asphalt shingles. The exterior is clad in vinyl siding and has modern windows and doors. The structure has a concrete foundation.

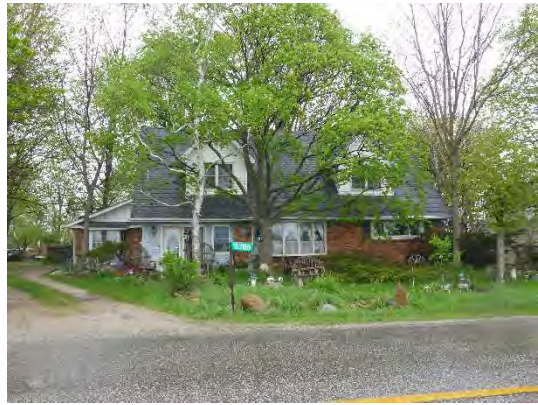
Description: The property contains a residence and outbuilding.

The residence is a one and a half storey structure with a high-pitched side gable roof with asphalt shingles. The front (south) elevation has two gabled dormers. The residence is clad in brick and vinyl siding and has modern windows and doors. The structure has an undetermined foundation.

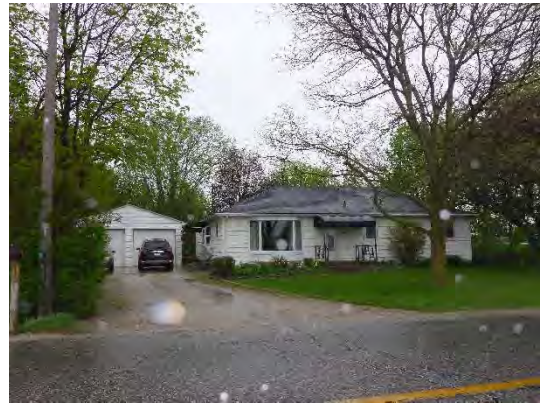
The residence is a one storey structure with a low-pitched hip roof with asphalt shingles. The structure is clad in vinyl siding and has modern windows and doors. The residence has a concrete foundation.

The double-car garage to the rear of the residence is a one storey structure with a gable roof. Its exterior is clad in vinyl siding.

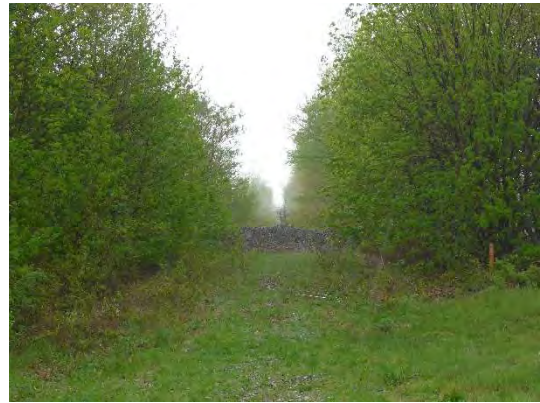
Description: The property contains the former railway corridor of the Michigan Central (M.C.) Railway. The rail line has been removed and is now a gravel path that is bordered by wood lots.

The railway line was between London and Windsor in 1890. The railway line was owned by M.C. until 1985, when it was taken over by the Canadian National Railway/Canadian Pacific Railway.

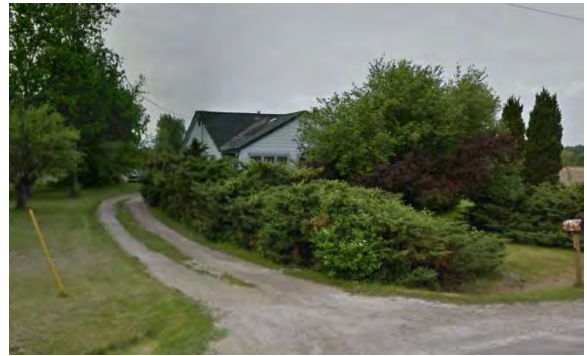
Description: The property contains a residence, and two outbuildings. The view of the residence is obstructed by vegetation.

The residence is a one storey structure with a medium-pitched cross gable roof with asphalt shingles and a concrete chimney. The exterior is clad in vinyl and a mixture of 3/1 wood windows and modern windows. The structure has an undetermined foundation.
